Keels Falling Off

by
Geoff Van Gorkom
Van Gorkom Yacht Design

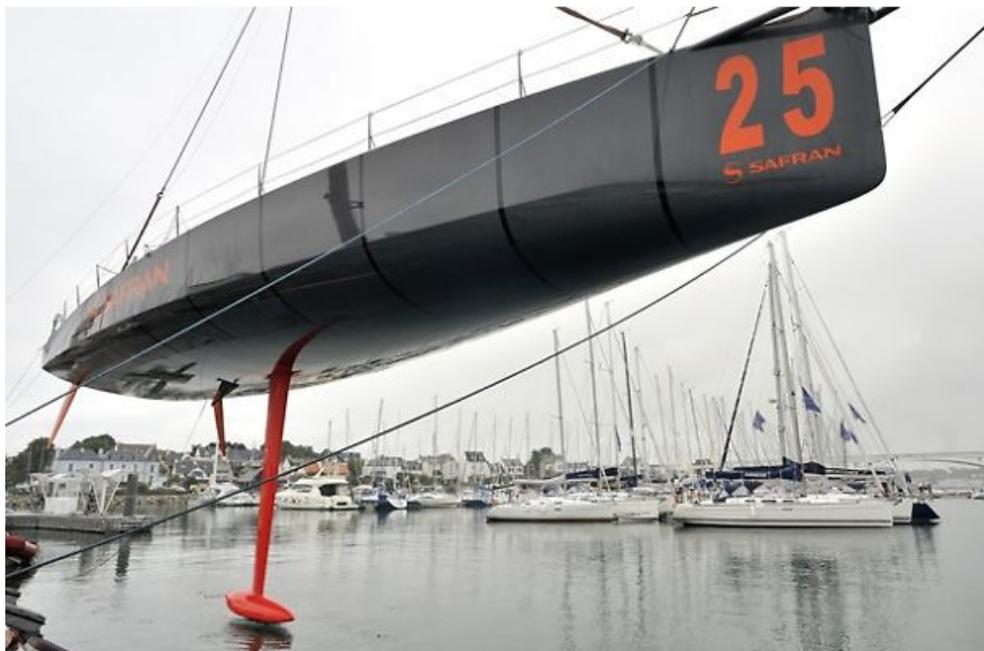
Unfortunately there are many examples of what happens when people don't get it right. This was the case with Marc Guillemot's IMOCA 60 SAFRAN which was forced to retire from the 2012 Vendee Globe after its hollow Titanium canting keel failed. The investigation showed that the damage to the keel fin was due to metal fatigue caused by repeated shock loads from wave action. While titanium is much stronger and lighter than steel it is a more brittle material with a lower elongation rate.

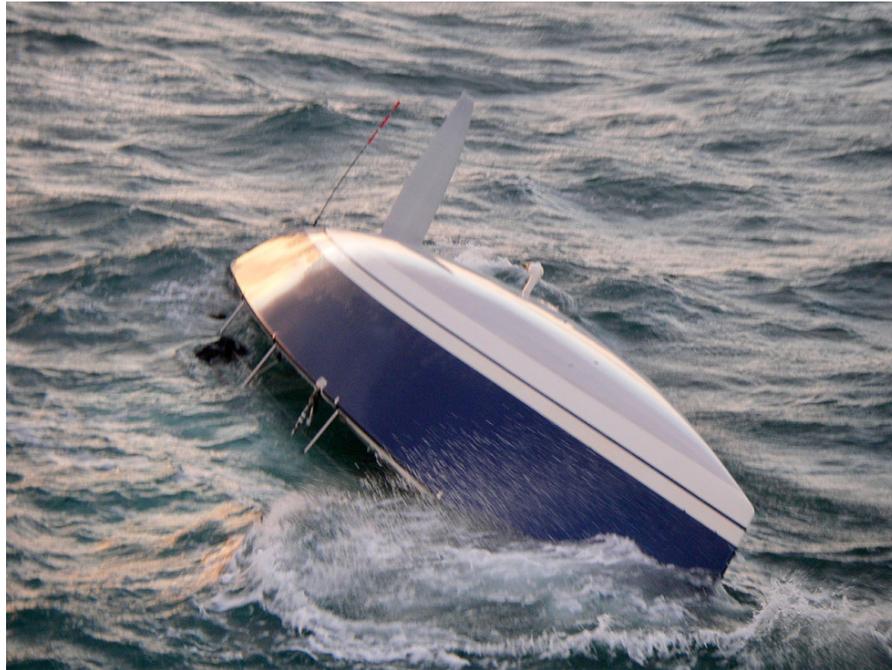
Example 1 - On the 2nd February 2007, the owner and four crew of the Max Fun 35 yacht *Hooligan V* sailed from Plymouth towards Southampton following out of season repairs and maintenance. At about 0320 on the 3rd, the boat's keel became detached and the boat suddenly capsized causing the loss of life of one crew member.

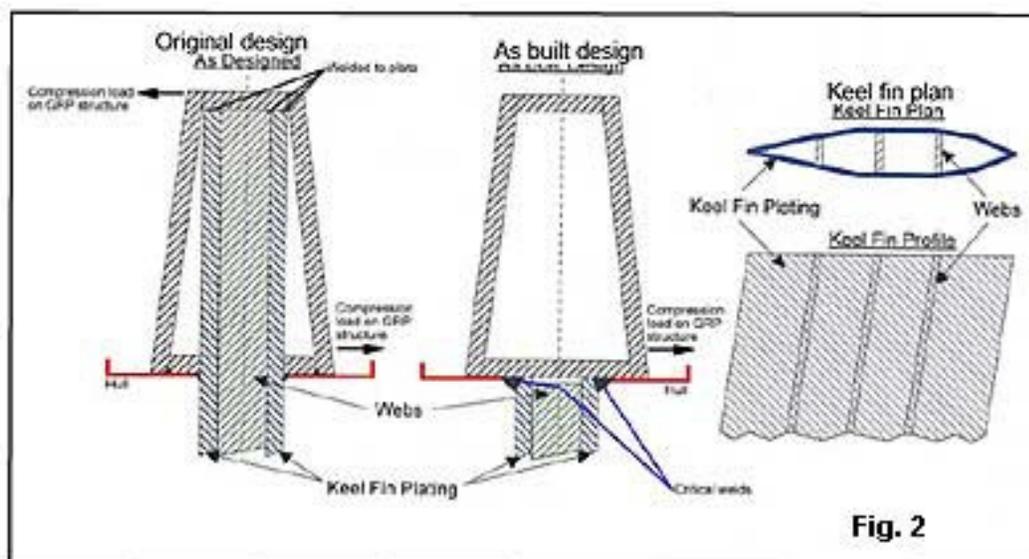
Fig. 2

Investigations found that the fabricated steel keel had failed just below the fillet weld connecting the fin to the taper box. Laboratory metallurgical analysis confirmed that the keel had suffered fatigue failure in the fillet weld area, which had been subjected to high bending stresses. Defects were also found in the keel taper box welds, and two of the three keel bolts had also failed.

It was further discovered that the builder had sub-contracted the hollow keel construction to a steel fabricator who had no marine experience. The fabricator changed the original design, and incorporated a fillet weld in a critical area, to ease manufacture and reduce costs, but without the supporting calculations to assess the stresses to which the keel would be subjected (Figure 2). He did not consult on the changes with the designer.

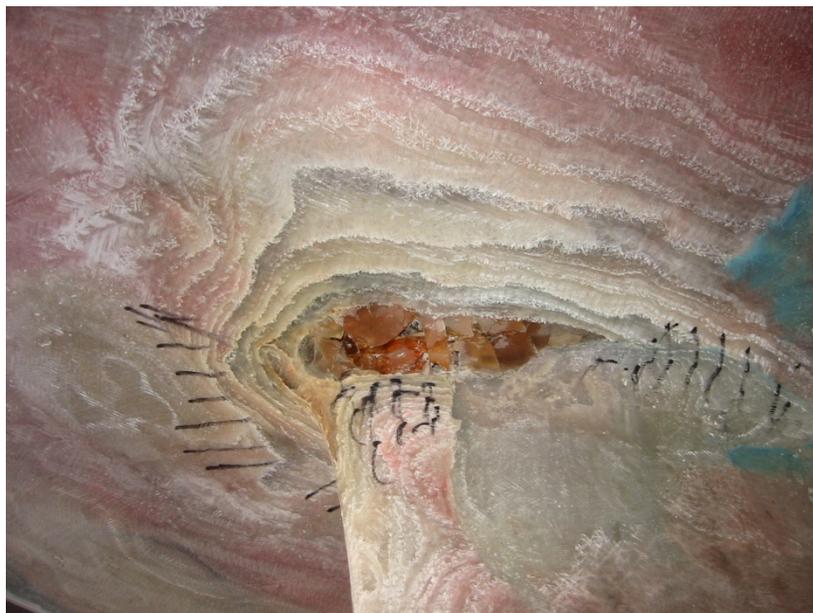
Example 2 - Van Gorkom Yacht Design was asked to get involved in the repair of a 40 foot cruiser/racer that went aground in Long Island Sound, damaging the keel (there was movement from side to side), the hull shell and the internal keel grid of the yacht. After a thorough investigation of the structure, which included thermal imaging, it was concluded that the besides the grounding damage there were significant flaws in the original construction of the boat.

This included dry spots in the hull laminate, under-building of the floor and girder structure (we were privy to the laminate schedule), and almost zero support for the aft two centerline keel bolts.

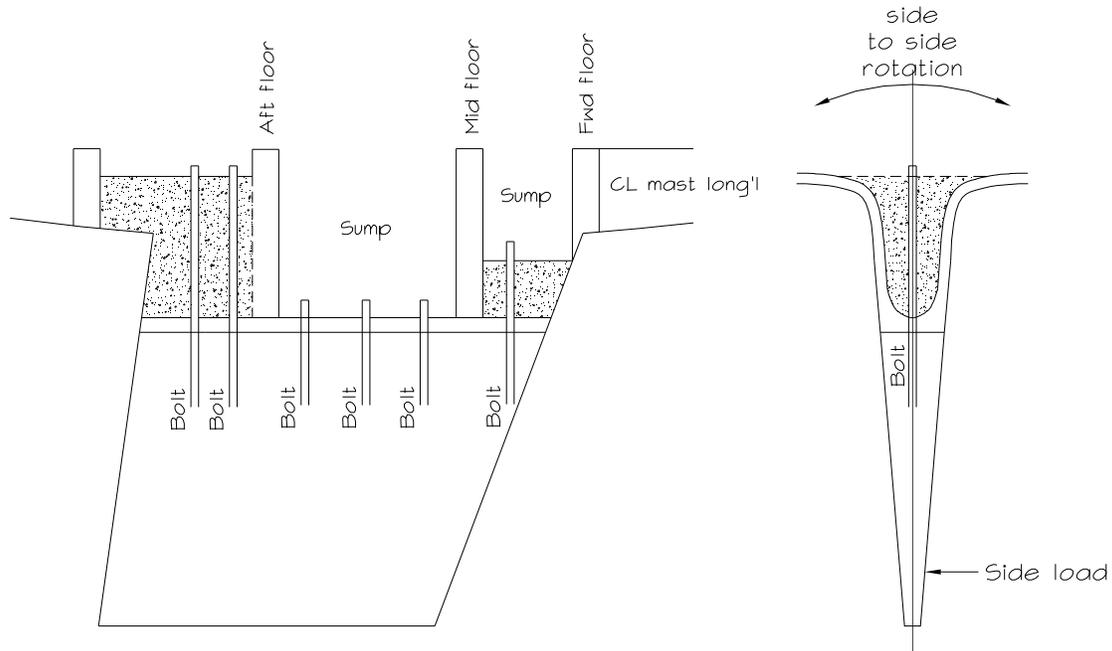
This boat has a deep sump so access to the nuts on the keel bolts is difficult. The forward bolts were manageable but the after centerline bolts were made longer and brought up through the sump which was filled in with high-density syntactic foam and glassed over. Backing plates went over the bolts and the nuts were torqued down.

What wasn't fully appreciated by the builder was that these aft bolts were relatively unsupported which placed a disproportional load on the remaining bolts leading an over stressing of the supporting structure and contributed to a "wagging" keel.

VGVD recommended grinding out all the high-density syntactic foam in the after sump and exposing the aft face of the aft floor. Then glue in sister plates on the front and back faces of this floor, making sure they went down to the bottom of the sump. These would then be tabbed in all around the hull and over the cap of the floor. We then recommended pouring an epoxy and chopped fiber mix into the aft sump area with G-10 compression tubes over the keel bolts. This was followed by glassing over the area, making sure there was a good bond with the tubes. Stainless steel backing plates were fabricated to span from longitudinal stringer to longitudinal stringer in order to distribute the load.

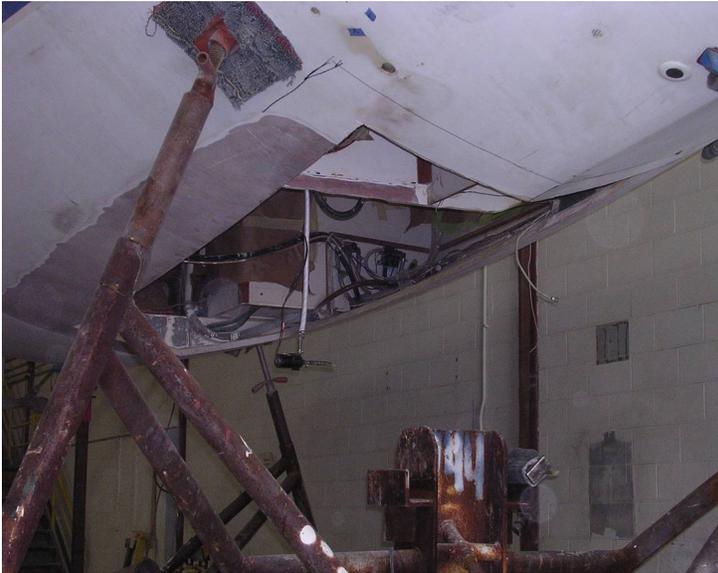
When the keel grid and sump area of this 41 foot production boat was found to be severely compromised, Steve Burke of Burke Design recommended the entire bottom of the hull in way of the keel be cut out of the boat and a new section be laminated up and put in its place. He jokingly yet appropriately calls this a "sumpectomy".

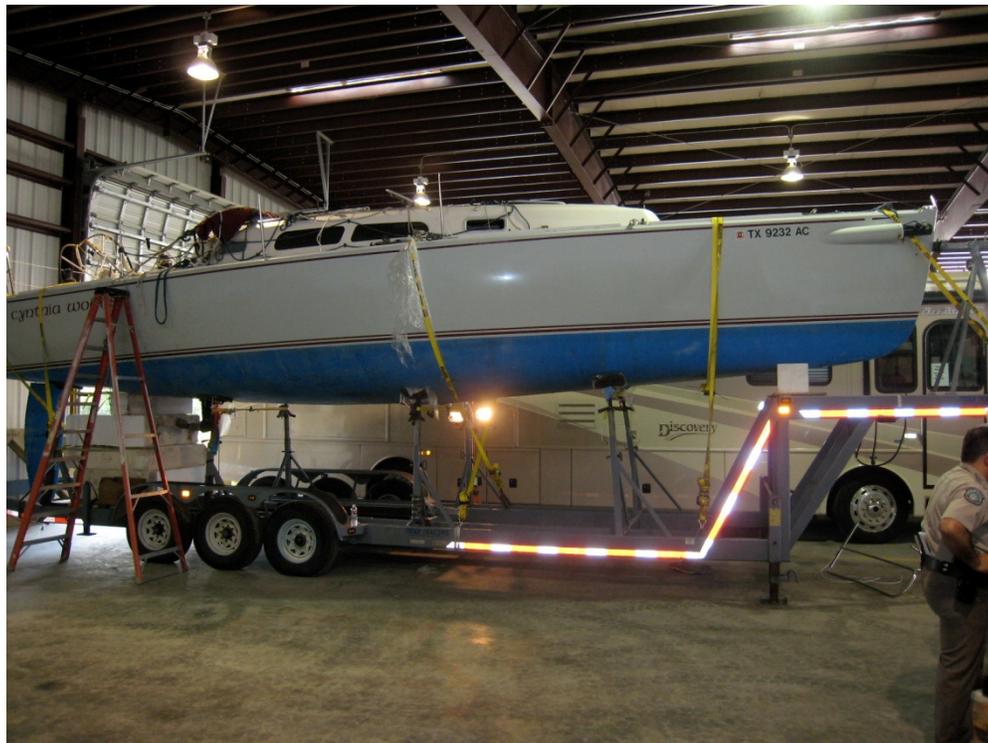
On 6th June 2008, the Cape Fear 38 “Cynthia Woods” was competing in the Regatta de Amigos from Galveston, Texas, to Veracruz, Mexico, with four Texas A&M students and two safety officers onboard. At approximately 23:00 the yacht suddenly and unexpectedly began taking on water at a very rapid rate and capsized and sank after its 5,000-pound keel fell off. 53 year old safety officer Roger Stone perished after he managed to push two students out of the cabin to safety. The four students and another safety officer drifted in the Gulf of Mexico for 26 hours before being rescued.

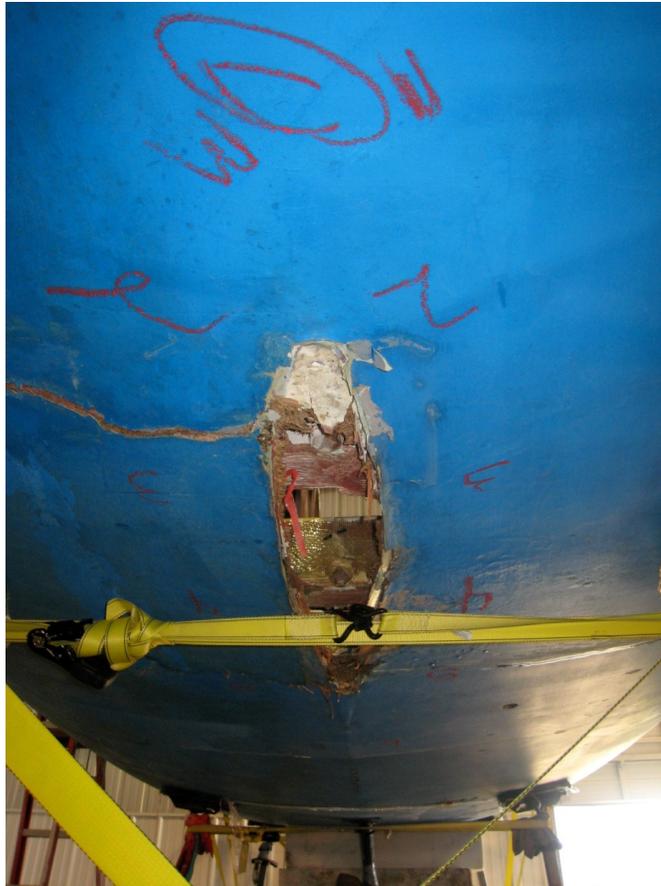
The fact that there was movement in the keel grid so as to have caused cracking in the fiberglass should have been enough of an indicator that the boat had a problem and that there was shear failure occurring in the laminate. What wasn't immediately evident was the unusually thin hull shell in way of the keel which eventually failed and ripped out of the bottom of the boat along with the keel still attached.

View looking up at where the keel should be

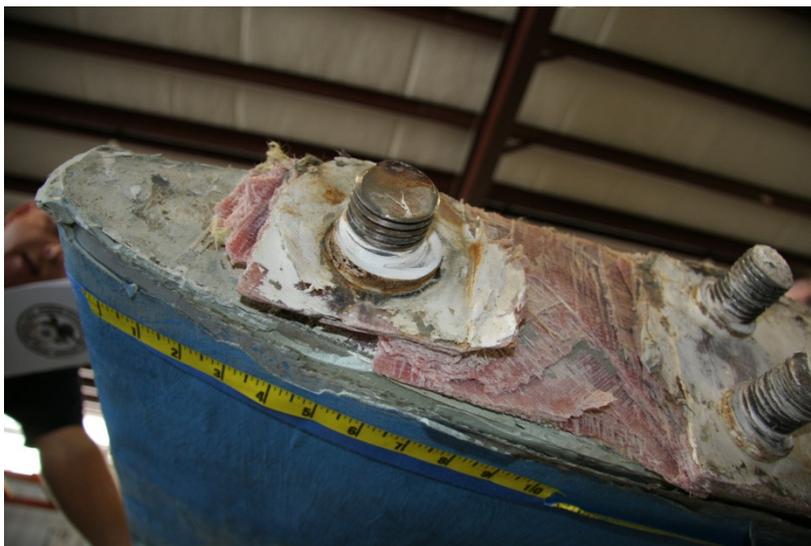
Keel with hull laminate still attached
